Corrosion of Aluminum Pipe

corrosion of unprotected aluminum irrigation pipe can lead to serious problem under one or more of several conditions

Martin R. Huberty

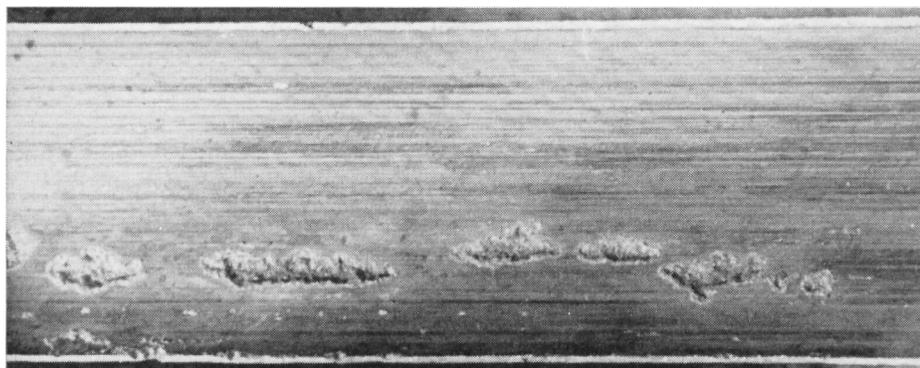
Corrosion often occurs in straight lines parallel to the axis of the pipe.

Injury was most common along straight lines indicating a possible lack of uniformity in the extruded alloy, or from scratches made by a rough edged mandrel or from other causes. Also, damage was greater usually in the main line than in the secondary lines. Couplings were found to be most heavily corroded just inward from the gasket. Pitting of the pipe was initiated on the inside surface and progressed outward.

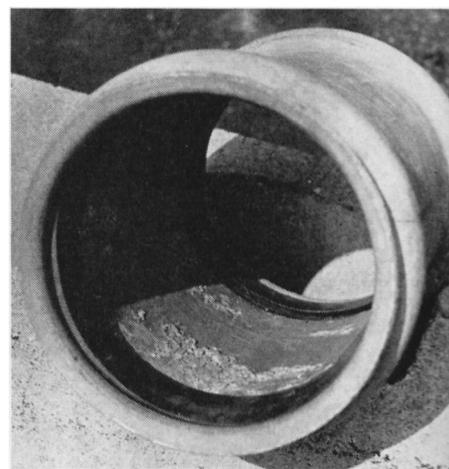
Right—Characteristic corrosion pattern in the pipe couplings.
