# TED GOLF GREENS d to Deep Aeration, rolled Irrigation

## SAN BERNARDINO COUNTY TESTS

F. W. DORMAN · C. L. HEMSTREET

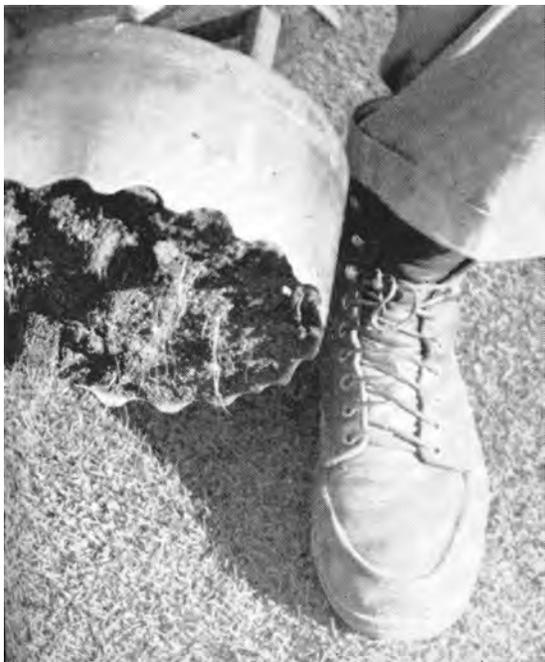
Good grass root growth extends through backfill material in drilled holes in this turf renovation test.

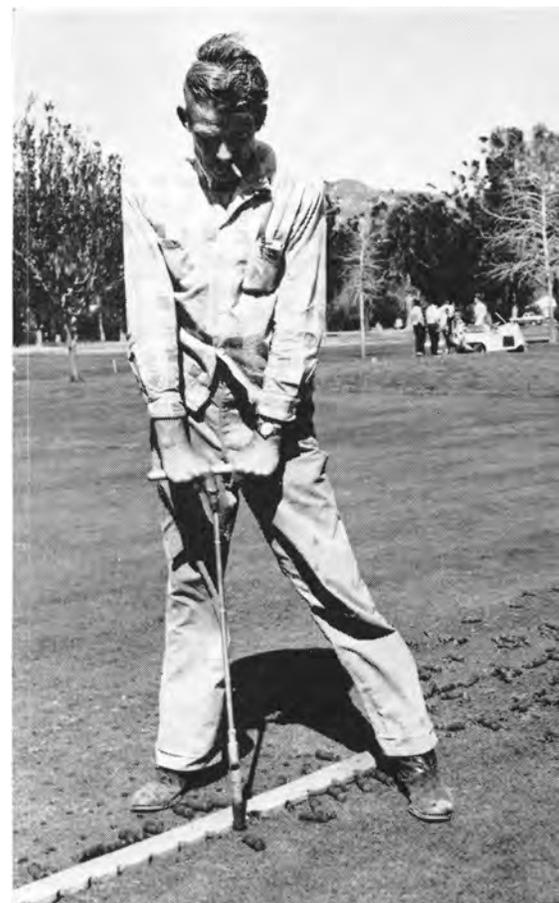
Deep aerifying with a soil tube, to increase water penetration on an old golf green. The notched board insured accurate spacing at 2 inches for the test.

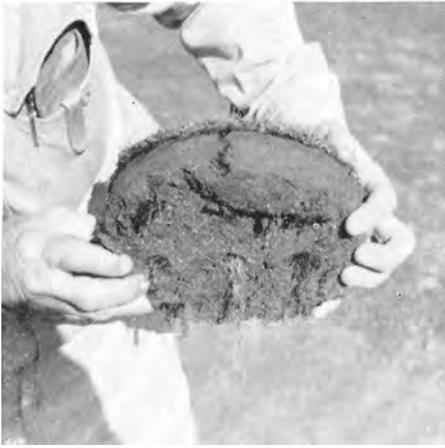
Section of turf shows good grass root growth through backfilled material in drilled holes in renovation test.
