Pea Gravel For In

D. D. HALSEY · A. W. MARSH

Envelopes Tile Drains Coachella Valley

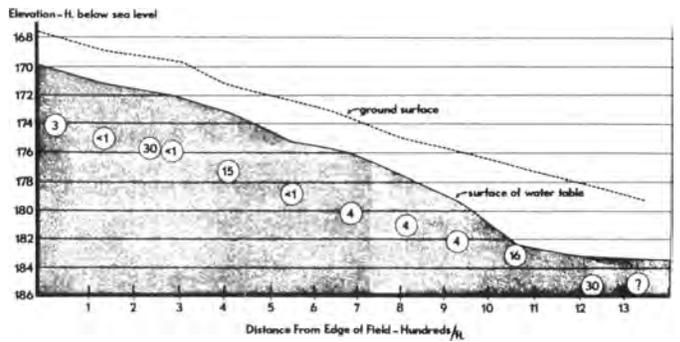
Graph 1. Profile of John Jones orchard, Mecca, Feb. 1966 before installation of new tile drains. Circles represent tile drains with top of circle at elevation of the top of the pipe. Figures in circles show flow from end of lateral in gpm/1000 ft of pipe. Water table determined from piezometers set on top of drain in the gravel envelope. Grove had not been irrigated for two months.

impermeable strata in the soil prevented movement of water to the drains. However, while the ditches were being dug, it was evident that the water stood at about the same level over the tile lines as at the midpoint between them, and no benefit was achieved by the ditch digging. There was relatively little flow from most laterals, and piezometers set directly on top of the drain pipe in the sandy envelope had several feet of water in them (graph 1).

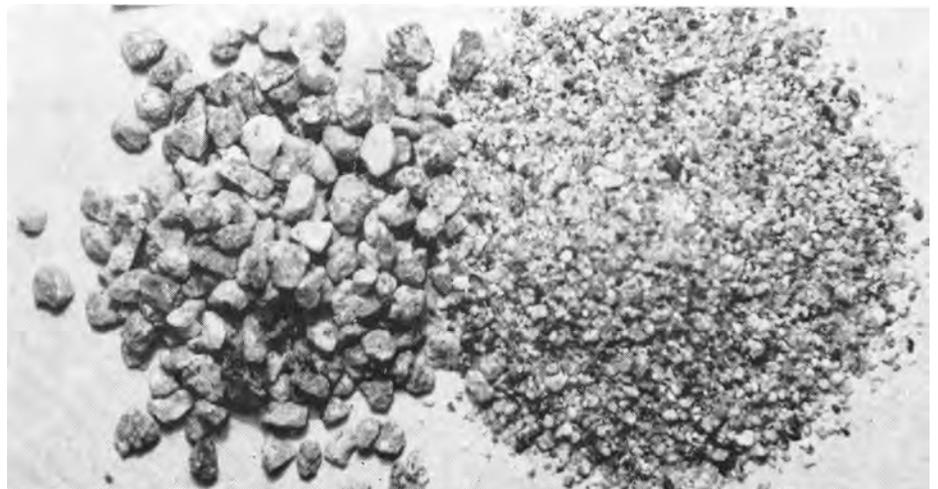
mental tile lines using a different gravel envelope. Instead of the “pit run” sand which had been used in the nonfunctioning lines, a pea gravel was used. A sieve analysis of these gravels and a typical sample of the soil from this place are shown in graph 2. Selection of this gravel was based on the assumption that the old lines failed because the envelope material used about them was little, if any, more permeable than the soil itself, and that its fine texture allowed it to flow (when under pressure) into the gaps between adjacent joints of the pipe. The pea

“Clean clause” pea gravel (left) used around John Jones tile lines, as compared with standard “pit run” gravel (right) used around old lines which failed.

gravel chosen was of a texture too large to permit flow into the gaps between pipe sections.

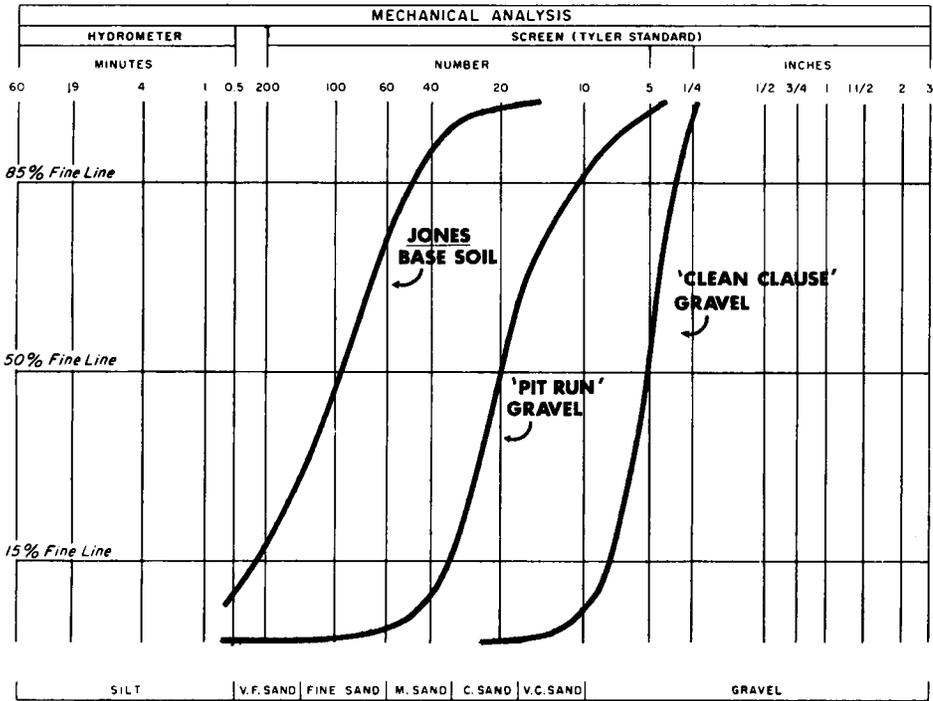
Graph 2. Sieve analysis of base soil, "pit run" gravel and "clean clause" pea gravel from the John Jones ranch, Mecca, sketched on a standard SCS mechanical analysis chart.

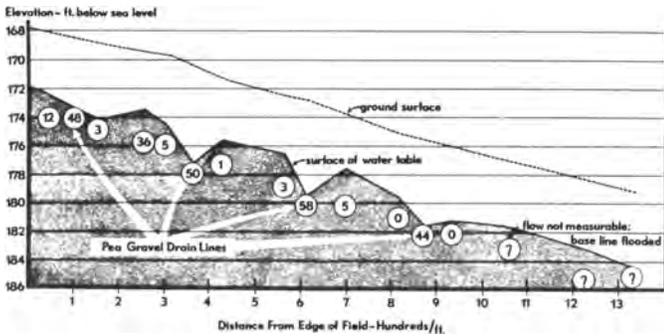
The water-table position on the Jones farm was located with auger holes and the four experimental lines were distributed equidistantly over the 23.5 acre area, which made a spacing of 240 ft. Installation was completed in March of 1966. The flow from these lines was far greater than from any of the old lines (graph 3), and at no time in the year since they have been in place has any water stood over them. They have maintained the general water table at acceptable levels (graph 4) and tree condition has returned to normal. It is interesting to note that the total amount of water removed by these lines has been in excess of the amount of water applied to the grove (graph 5)—resulting from the water-table lowering, and inflow from other properties up the slope.

Graph 3. Profile of John Jones orchard, Mecca, Oct. 28, 1966, during an irrigation (same methods and notation as in graph 1). New pea gravel lines were carrying most of the water, had no water over them, and had lowered the general water table. (Water flow calculations were made by G. J. Hoffman, U.S. Salinity Laboratory, Riverside.)

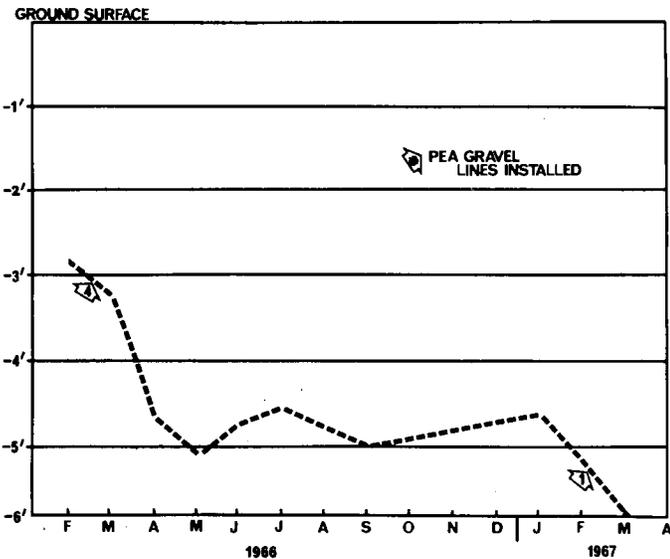
Graph 4. Depth of water table below ground surface on John Jones plot, Mecca. Graph shows average of 44 auger holes uniformly distributed throughout the 23.5 acre area. Each hole was located 12 ft away from an old tile line, already in place when the trial was begun. Four pea gravel lines (R, S, T & U) were installed in March 1966, one (V) was installed in Feb. 1967.

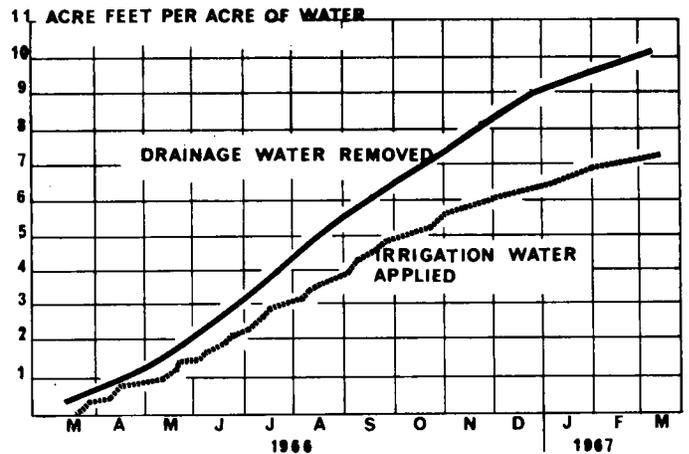
Graph 5. Irrigation water applied, compared with drainage water removed by four pea gravel drain lines from 23.5 acre plot area of John Jones ranch, Mecca.
