Reclamation of a

A poorly drained Coachella Valley vineyard that suffered the loss of half its vines from salt damage has been reclaimed in six years by re-leveling the ground, changing the irrigation practices, and switching from the use of the highly saline Colorado River water to the use of a high-quality well water.

COACHELLA VALLEY GRAPE RANCH

by changes in levelling, irrigation, and water source

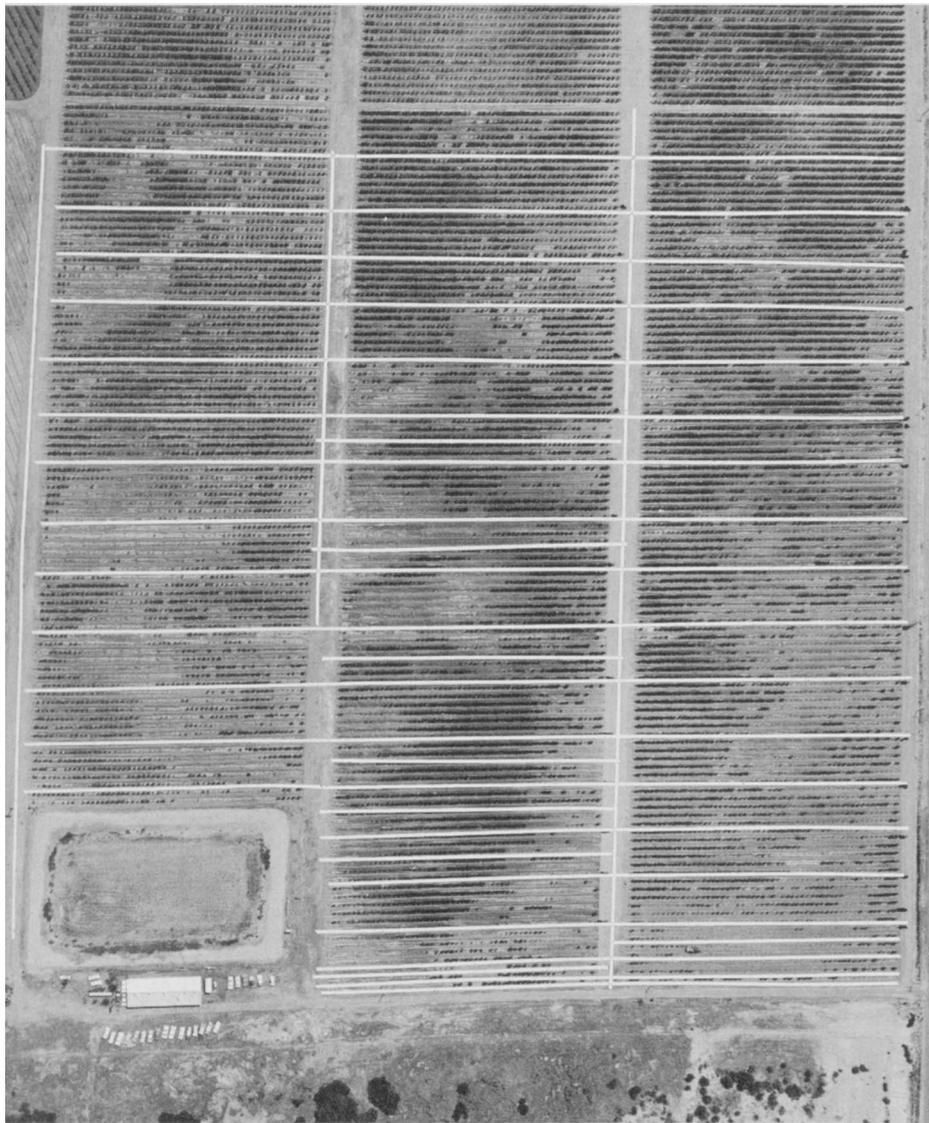
Aerial Photo of the test vineyard in March of 1963 at the start of reclamation. White lines show location of tile lines totalling 603 lineal feet per acre at a cost of around \$600 per acre. Notice the location of the poor vines is not correlated with location of the drains.
