# Evaluation of center-pivot sprinkler systems

Blaine R. Hanson □ Donald L. Lancaster

## *Some causes of nonuniformity are correctable*

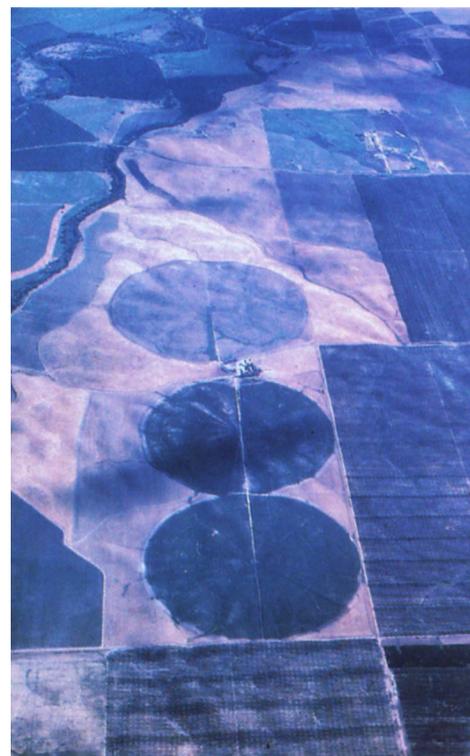
Driven by water or electric motors, 1,300-foot-long center-pivot sprinklers can, in two days, irrigate 150-acre circles in one sweep. Nonuniformity of applied water can result from faulty design or maintenance.
