Spring Flow Affected by Brush

removal of nearby deep-rooted plants improved water flow of springs in studies in foothills of Madera and Lake counties

H. H. Biswell and A. M. Schultz

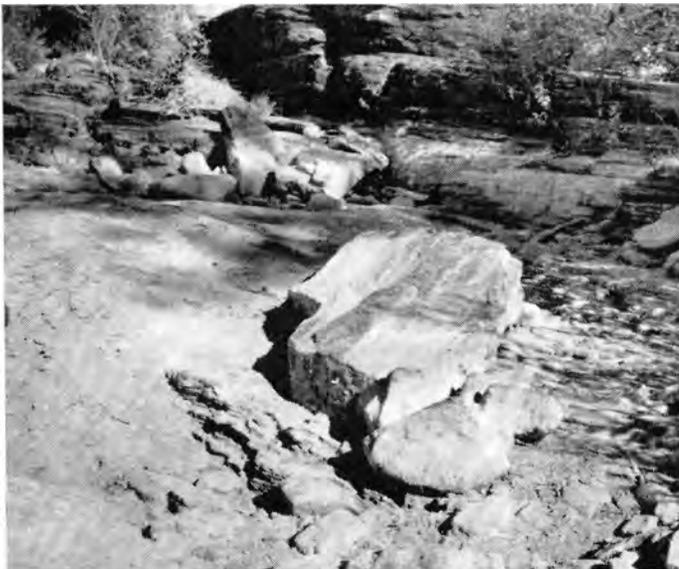
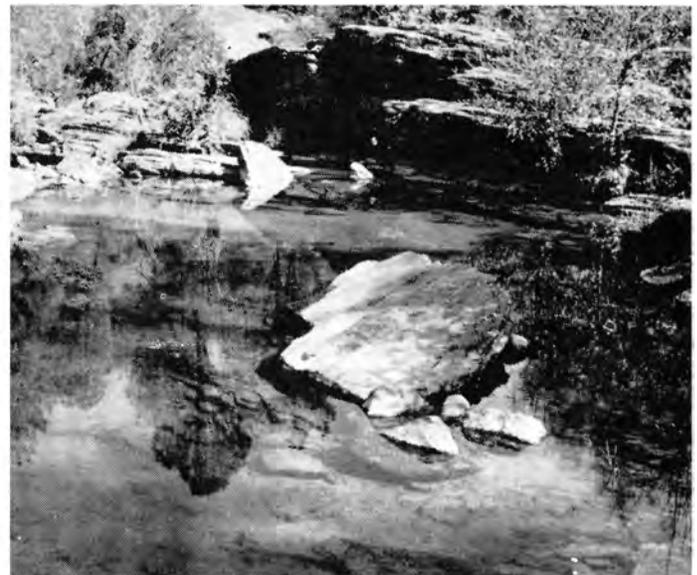
Finegold Creek. Left, dry streambed before control burn. Right, stream flowing three weeks after burn.

Following the first burn it was obvious that water increased in certain places in the creek but no photographs were taken or definite measurements made before the burn. However, three days prior to the second burn, photographic stations were established in the streambed which was nearly dry except for depressions that had filled with water following the first burn. These stations were re-photographed about three weeks after the burn when water was flowing down the creek. How much of the increase in flow resulted from the killing of the vegetation in the streambed and on the slopes or

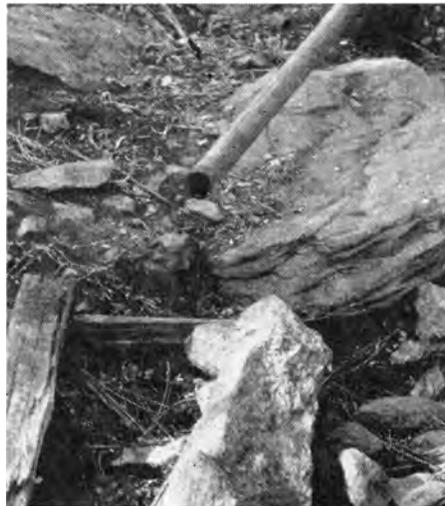
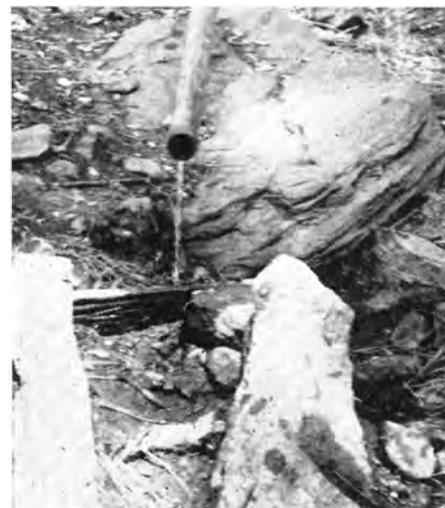
Above: before control burn of watershed, Grapevine Spring dripped 1.5 gallons of water per day. Below: after watershed was control burned, spring flowed 360 gallons per day.

The watershed above Grapevine Spring was 59 acres and was control burned on August 20, 1949. Coverage of brush and trees before the fire was estimated as 50%. The reduction in transpiration area by burning was approximately 80%.

Before the burn the spring produced 1½ gallons per day and 24 hours after the fire it produced 360 gallons per day.
